# Durability Of Acrylic Waterproofing Membranes For Wet Areas

BL Schafer  
CSIRO Appraisals Victoria Australia

**Summary:** In recent years, environmental pressures have resulted in increasing use of acrylics as waterproofing membranes. A major barrier to the use of these materials has been concerns about the service life that they will achieve. CSIRO Appraisals has developed a testing protocol for the evaluation of the long-term serviceability of these materials, and this paper discusses the testing protocol and the interpretation of the results, including how they can be used to determine the suitability of a membrane to protect different substrates. As acrylic waterproofing membranes have a wide variation in their water vapour transmission rate, the paper includes the additional testing required to determine the suitability for use over substrates according to the water vapour transmission rate.

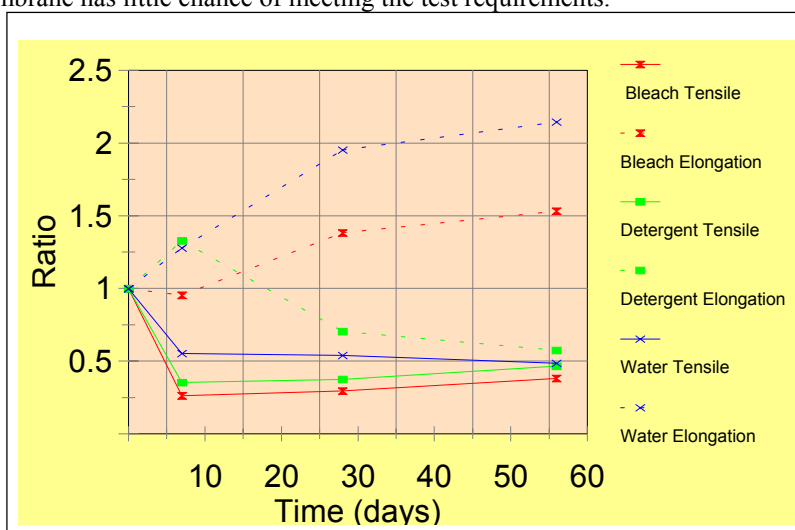
Initially, it was thought that testing at 7, 14 and 28 days would give all the data required. But as can be seen in Fig. 1, there is a reversal of the trend sometimes after 7 days and, to get a reliable result, the testing was extended to 56 days. In these tensile test figures, the ordinate is a comparison of the exposure result to that of the control for the sample under test. Using this ratio enables both elongation at break and tensile strength to be graphed on the one plot for comparison. In other figures, it enables direct comparisons of the relative performance of different membranes. In the initial development of the testing method, the 14-day testing increment was continued. However, as the method was to become a standard test, and costs needed to be contained, the test exposure times finally chosen were 7, 28 and 56 days. The 7-day exposure was used in preference to 14, as it will show early if a membrane has little chance of meeting the test requirements.

**Figure 1. Tensile strength and elongation at break results for membrane C**

property to be maintained. Often, the membrane softens during exposure to both water and bleach, as happened with membrane C (Fig. 1). For both of these exposures, membrane C has had an increase in elongation at break with a corresponding reduction in the tensile strength. After the initial 7-day exposure to the detergent, this is not the case, with a loss of both elongation at break and tensile strength. A loss in both properties indicates that the membrane material is suffering some fundamental loss of its intrinsic property. In the case of membrane C, there is not sufficient loss under exposure to detergent to be of concern, with it keeping just over 50% of its initial elongation.

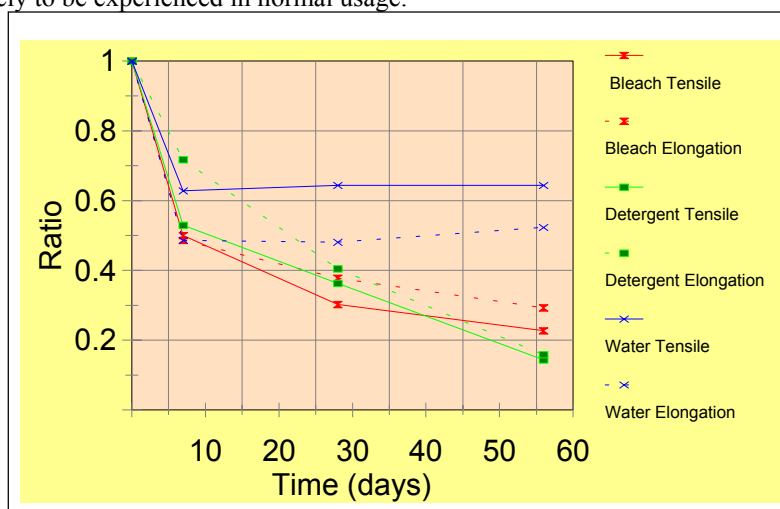
The results for membrane A are shown in Fig. 2. These are not nearly as convincing, with the continual loss of both properties on exposure to both bleach and detergent continuing significantly between the 28- and 56-day results.

**Figure 2. Tensile strength and elongation at break results for membrane A**

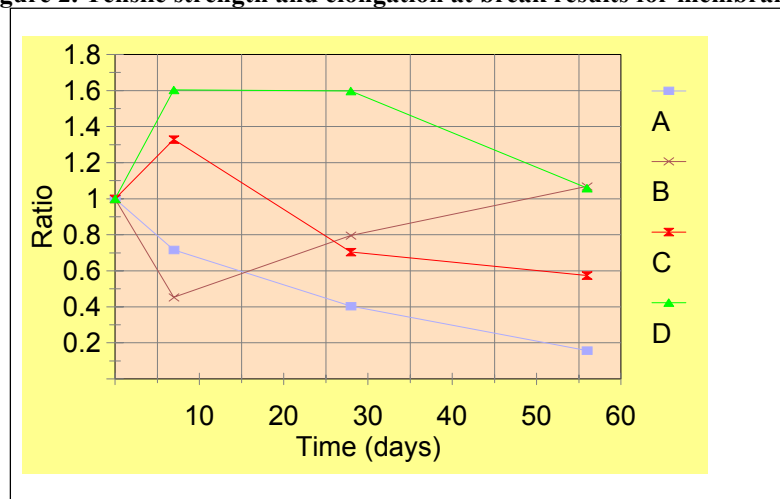
The results for elongation at break for all four membranes exposed to detergent are given in Fig. 3. Membrane B shows a significant change in the results between 7 days and both 28 and 56 days. This reversal was observed for many of the membranes that we have tested and is an example of why extending the testing out to 56 days, rather than finishing at 28 days as originally proposed, is warranted. The results for tensile strength for all four membranes exposed to detergent are shown in Fig. 4. The rapid loss of both tensile strength and elongation at break for membrane B at 7 days, having lost over 50% of its elongation at break and about 50% of its tensile strength, would indicate that this membrane was unlikely to meet its long-term durability requirement. However, by 56 days it had virtually recovered all of its elongation at break while still retaining 25% of its tensile strength. Based on these longer exposure results, it was considered to be a satisfactory membrane for use in wet areas. The testing, as mentioned earlier, is using more concentrated solutions to show long-term effects to exposure to less concentrated solutions likely to be experienced in normal usage.

**Figure 3. Elongation at break for all four membranes on exposure to detergent**

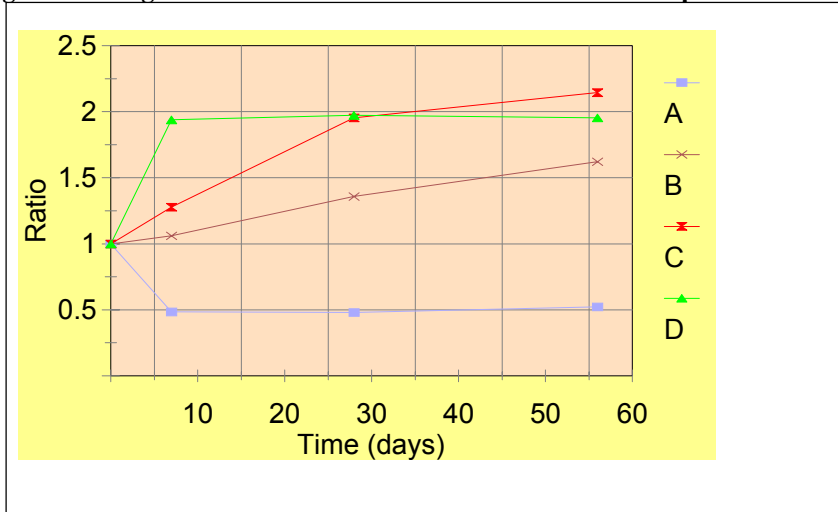
**Figure 6. Elongation at break for all four membranes after water exposure**

The pass/fail criteria finally chosen was to require that at least 40% of the elongation at break needs to be retained after 56 days exposure. It was considered that if the specimen had retained sufficient strength to enable it to be tested, then it had retained sufficient tensile strength. In practice, with correct specification of bond relief over areas where the membrane is expected to be stretched, the membrane will only fail if it is stretched beyond its elastic limit, as given by its elongation at break property. The results for all four membranes for their elongation at break after exposure to bleach is given in Fig. 5, and after exposure to water in Fig. 6. Thus, membranes B and C passed the test criteria while A and D failed to do so.

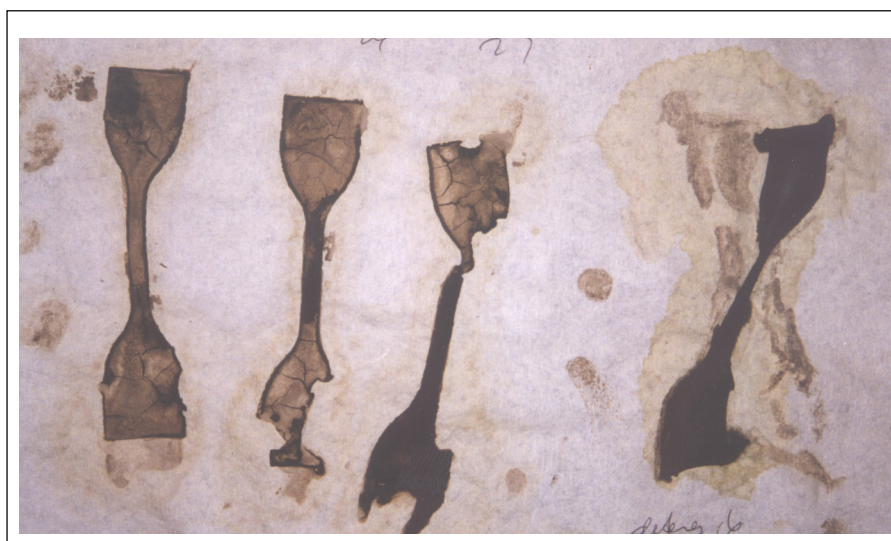
Some membranes that we have received for testing reach a stage of collapse at 7 days exposure and are not even able to be tested as shown in Fig. 7. The three on the left were exposed to bleach, while the one on the right was exposed to detergent. The worrying fact is that these were membranes that had been marketed for some time before they were tested for durability.

**Figure 7. Tensile test specimens that failed before they could be tested**
