## **DURABILITY OF FIBRE-CEMENT ROOFING CORRUGATED SHEETS**

### **ABSTRACT**

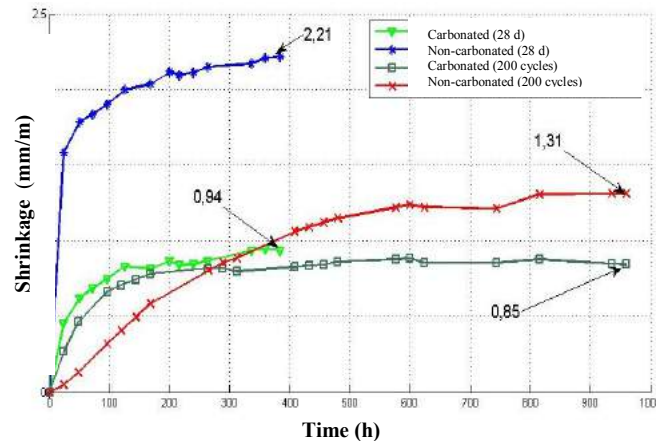
Figure 4: Variation on drying shrinkage composite over time.

Table 1 shows the water absorption and water loss for the half cycle (2 h 50 min), and the maximum absorption and water loss observed for up to 9 h (540 min). Water absorption was observed to be faster and almost completed within 2 h and 50 min. Differently the carbonated materials only demonstrated 68% of the maximum water absorption during immersion what can be understood by the lower incidence of open capillary pores. The sealing generated by the carbonation reaction prevents the material from absorbing water during the course of 2 h and 50 min, but the same is not true for the other treatments. This refinement of the pore structure and limited access of water to the fibrous composite may explain the lower shrinkage of the carbonated material before and after 200 aging cycles (Figure 4).
