Analysis of the severability of material layers of hybrid interior building components concerning repair and modernisation measures – Compilation of a practically oriented database for the sustainability assessment

This research project was funded by the research initiative "Future Building" of the German Federal Institute for Research on Building, Urban Affairs and Spatial Development (BBSR). (Project SF – 10.08.18.7- 09.4 / II 2 – F20-09-1-076)

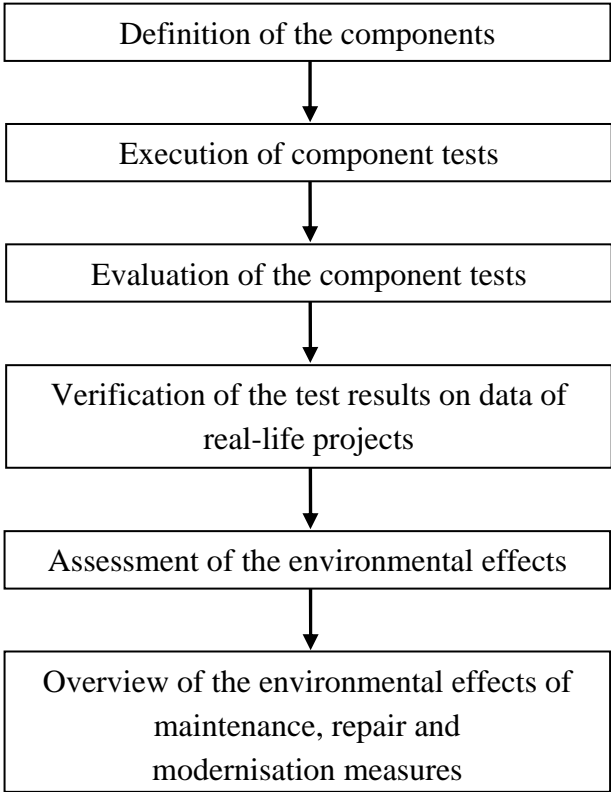
Figure 1: Procedure within the research project

different wall and floor systems. In addition, the results make possible a quantification of the environmental effects originating during modernisation measures which can fill the information gaps in existing lists of components. The procedure is displayed in Figure 1.

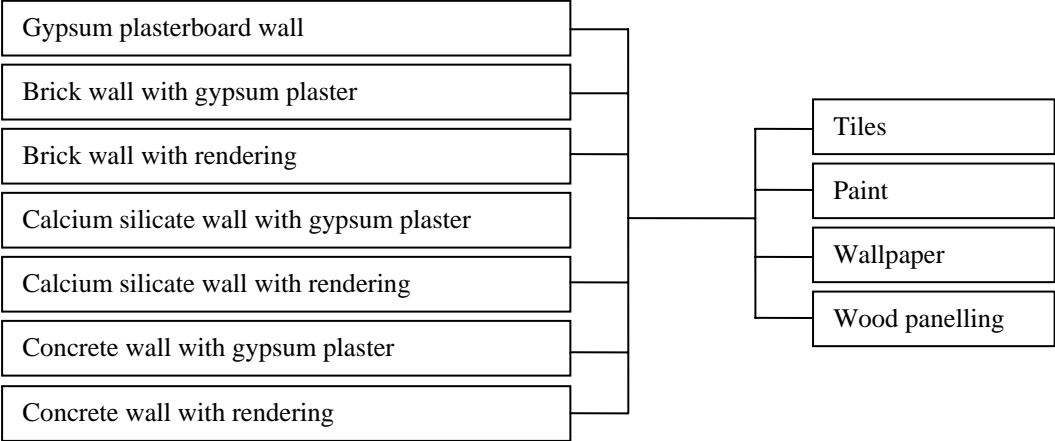
Figure 3: Wall constructions and wall cladding

As basic functional unity, „m² repaired component“ is taken for the study to enable comparability of the results of the balance of repair measures. To carry out realistic tests, the specimens are full-scale with the dimensions of the wall specimens of 2.0 m x 2.5 m (width x height) and floor specimens with the dimensions of 2.0 m x 2.0 m (width x length). These dimensions of the wall components are necessary to be able to simulate the labour over head as well as on floor level. Differentiated consequences on the quality of the severability and a practically oriented average value are to be expected due to the different positions with differently large effort and labour. Within the scope of the test series, the supporting structures and claddings shown in Figure 3 and Figure 4 were combined with each other.
