A new guideline for the planning and reconstruction of mortar joints and grouting of natural stone masonry, strategies for enhenced durability

Kurztitel:	Leitfaden für die Neuverfugung von Natursteinmauerwerk
	II3-F20-11-1-015
Forscher / Projektleitung:	Materialforschungs- und -prüfanstalt
	an der Bauhausuniversität Weimar
Projektleiter:	DiplIng. Heike Dreuse
Gesamtkosten:	211.854,40 €
Anteil Bundeszuschuss:	105.404,40 €
Projektlaufzeit:	06.2012 bis 11.2014

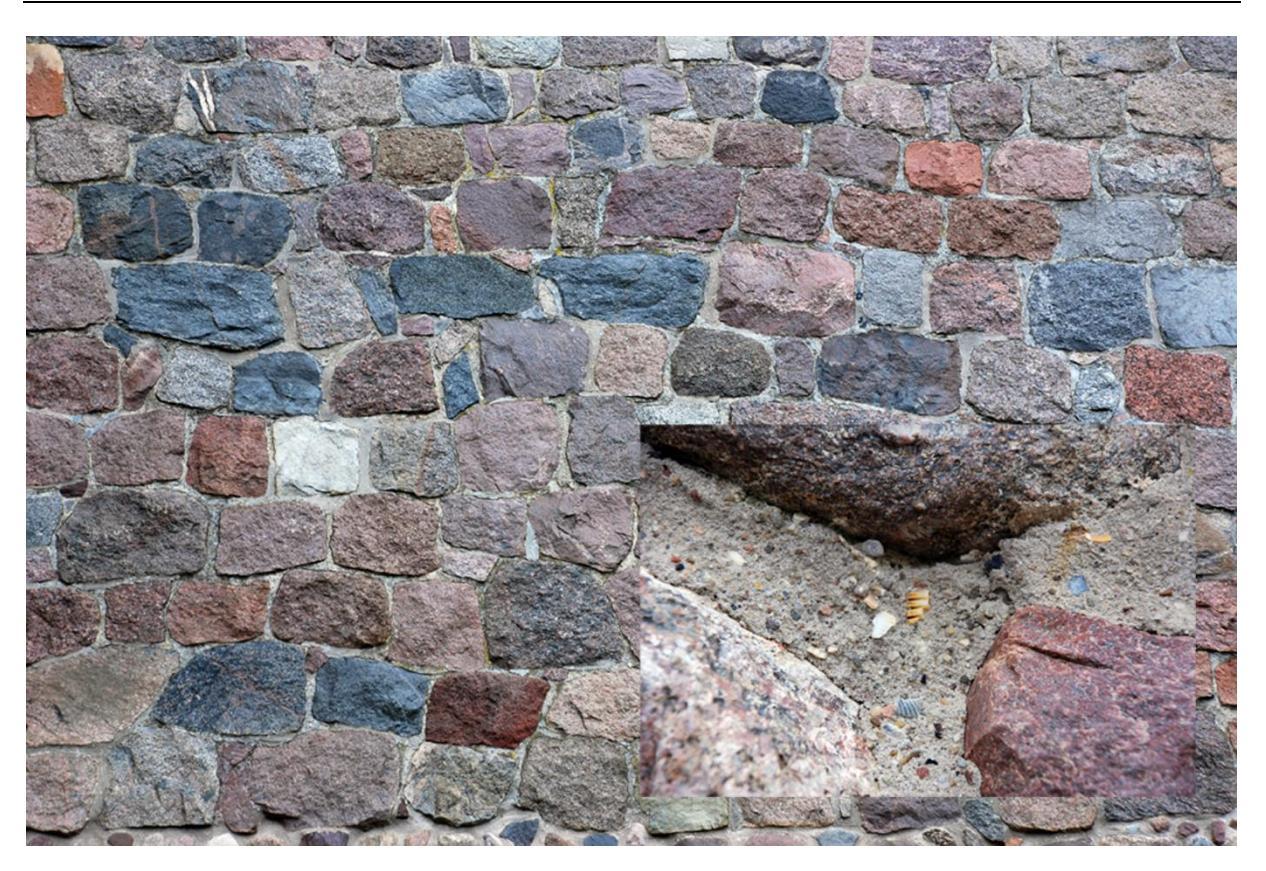
Fig 1: Jarmen.tif Fig 1: The local Church in Jarmen (Vorderpommern/Germany). Grouting with mortar that contains calcareous shell fragments.

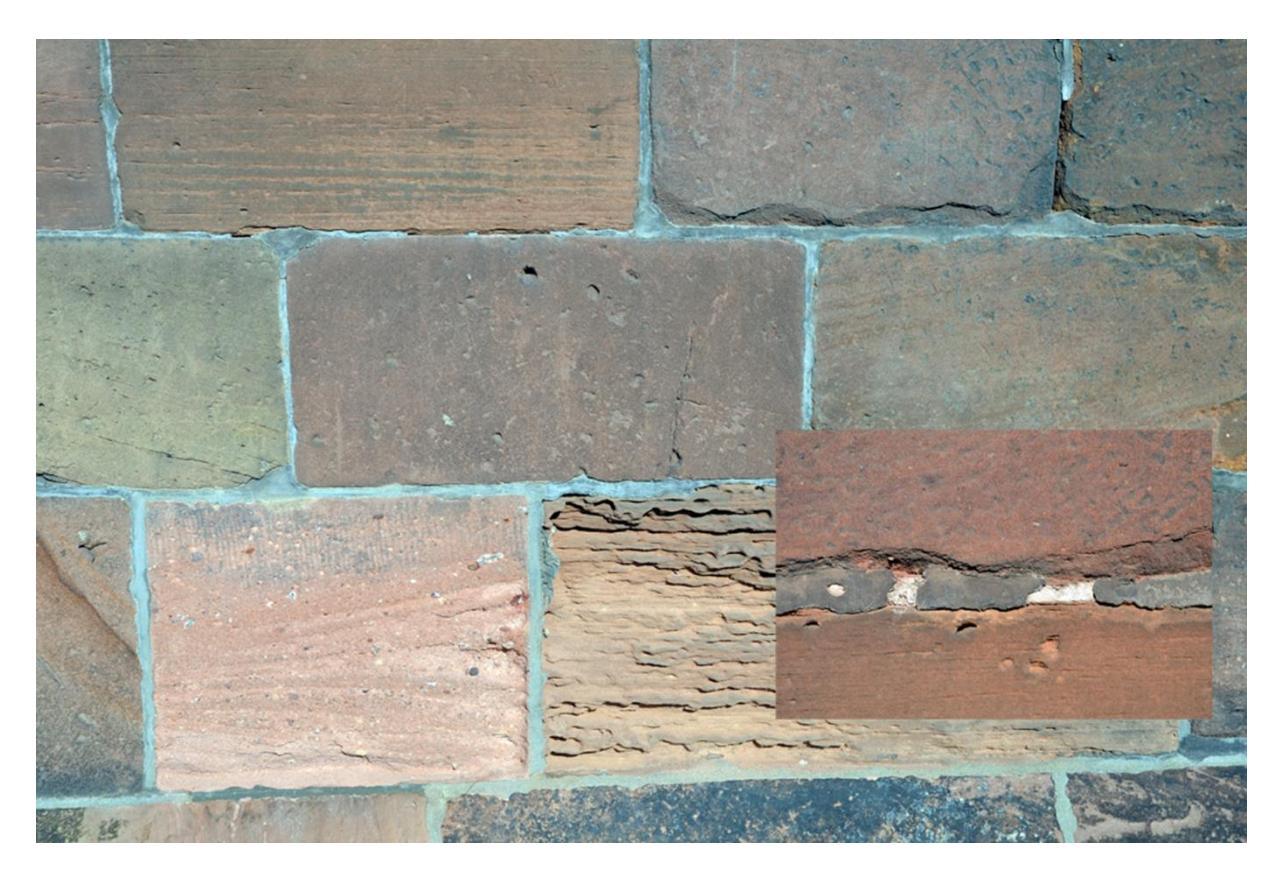
Fig 2: Worms.tif

Fig 2: Part of the masonry (outside, facade) of Worms Cathedral.

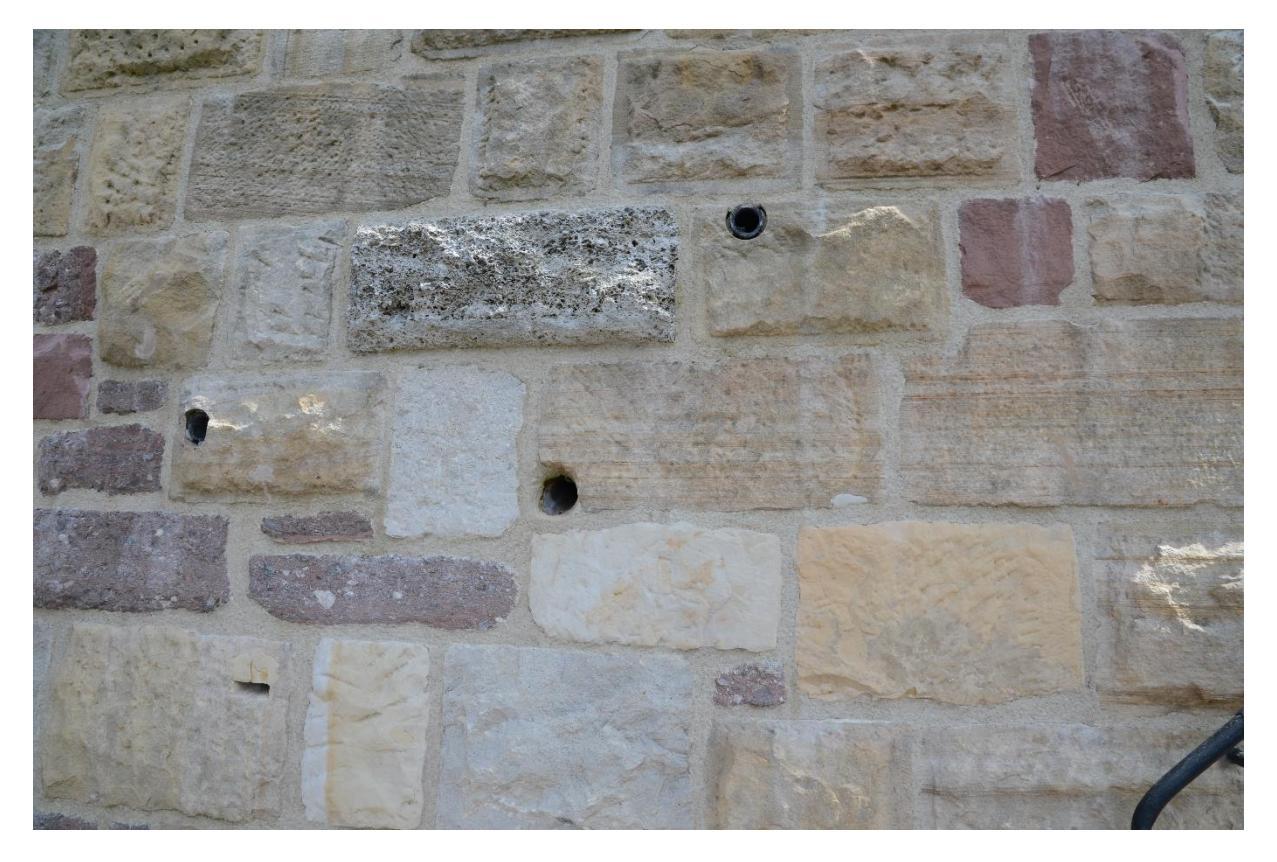
Fig 3: Wart_Pfeiler.tif Fig 3: Wartburg Castle at Eisenach, buttress of the defense wall, south-west side af-ter reconstruction and restoration.

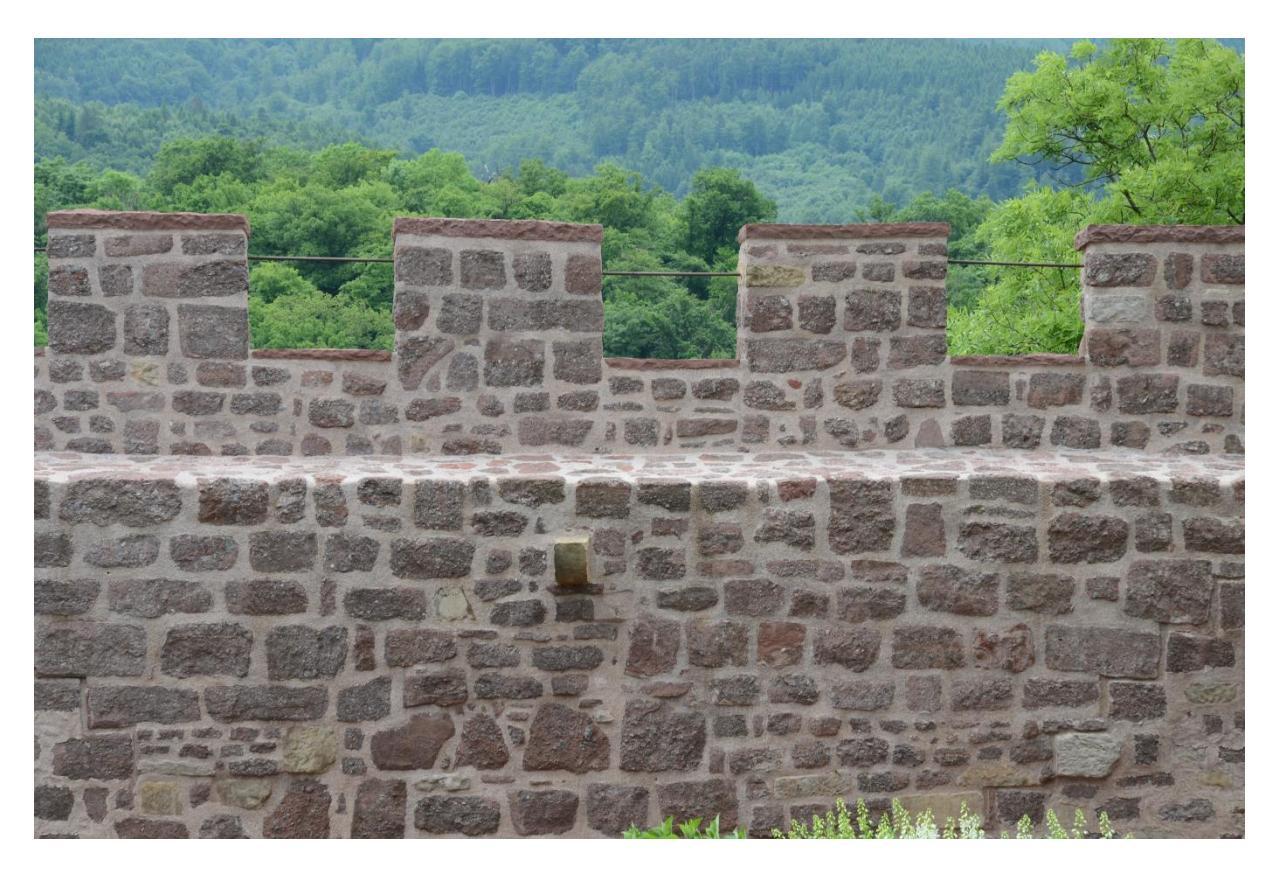
Fig 4: Wart_Wehr.tif Fig 4: Wartburg Castle – south part of the defense wall after reconstruction.

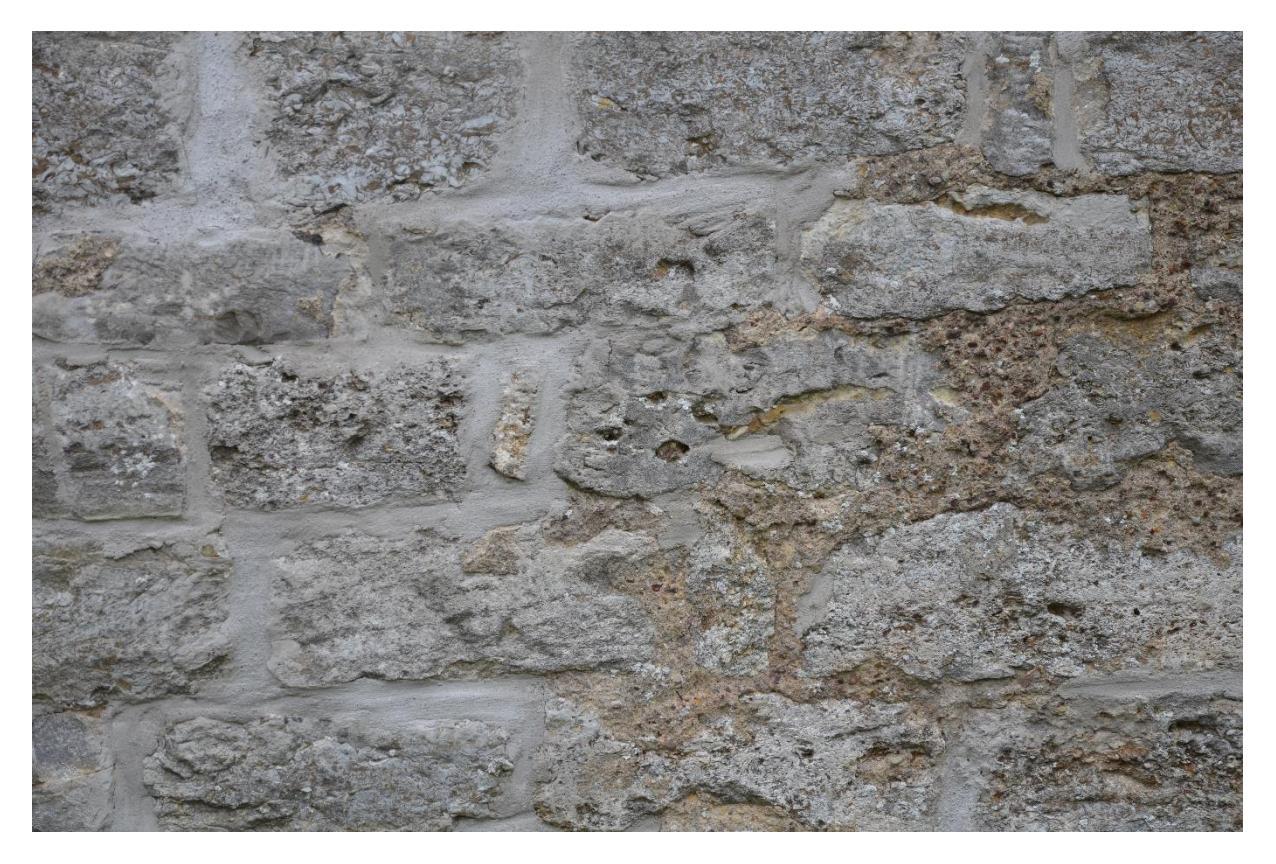
Fig 5: Kalksteinmauer.tif

Fig 5: Part of an isolated limestone wall in Niedergrunstedt close to Weimar/Thuringia showing new grouting (left side) and old mortar (right side).

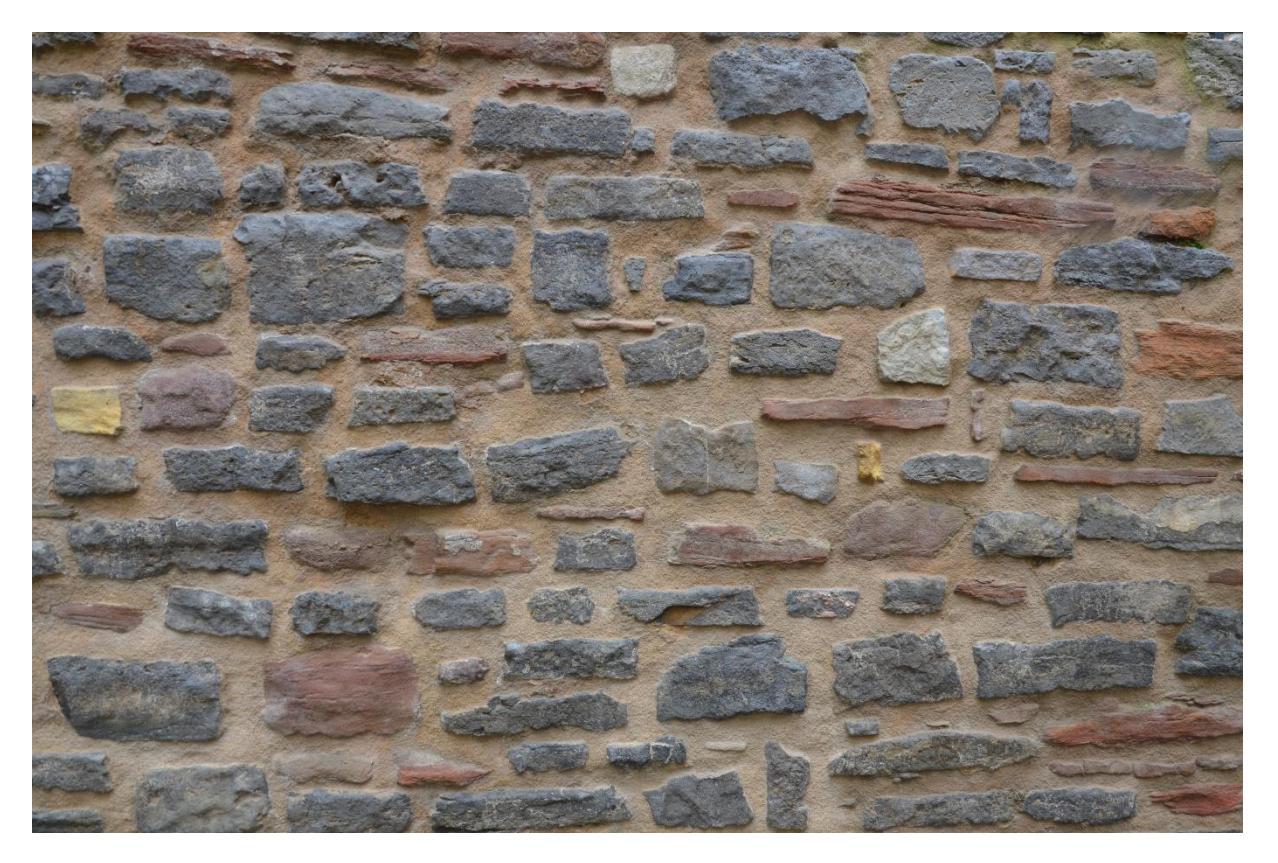
Fig 6: Mansfeld.tif

Fig 6: Mansfeld Castle – freshly restored part of the wall of the castle ruin Mittelort.

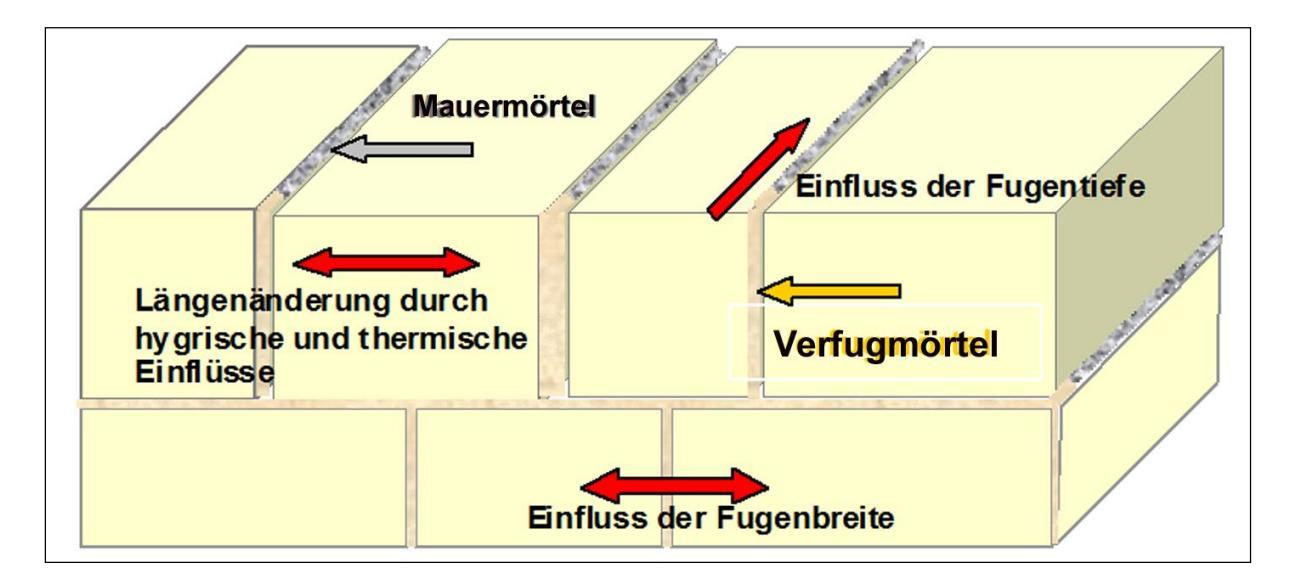
Fig 7: Schema.tif

Fig 7: Schematic draft of all the influences on masonry on joints and bricks and interdependencies.

The research project proved, that all factors mentioned above, led to different stresses and strains in the joints. They were estimated by magnitude to influence each other by way of interdependency. Especially in the case of decreasing joint width by stone swelling, this can lead to large compressive stresses in the mortar. Stones with high water absorption are due to swelling which decreases the width of the joints. The velocity of capillary water uptake leads to the swelling time, the real deformations are even more complex. By use of simulation tools, measurements on monuments, test walls and mortar samples deformation models for the processes could be gained and later on simulated. The results showed that as a second step even more data had to be acquired to arrive at realistic models. For the selection and mixtures for grouts a guideline has been developed. On each step the user has to decide on his own approach. Different alternative solutions are offered. The single steps are:
