Zukunft Bau

SHORT REPORT

Unmanned Aerial Vehicles (UAV) for Condition Determination of Structures

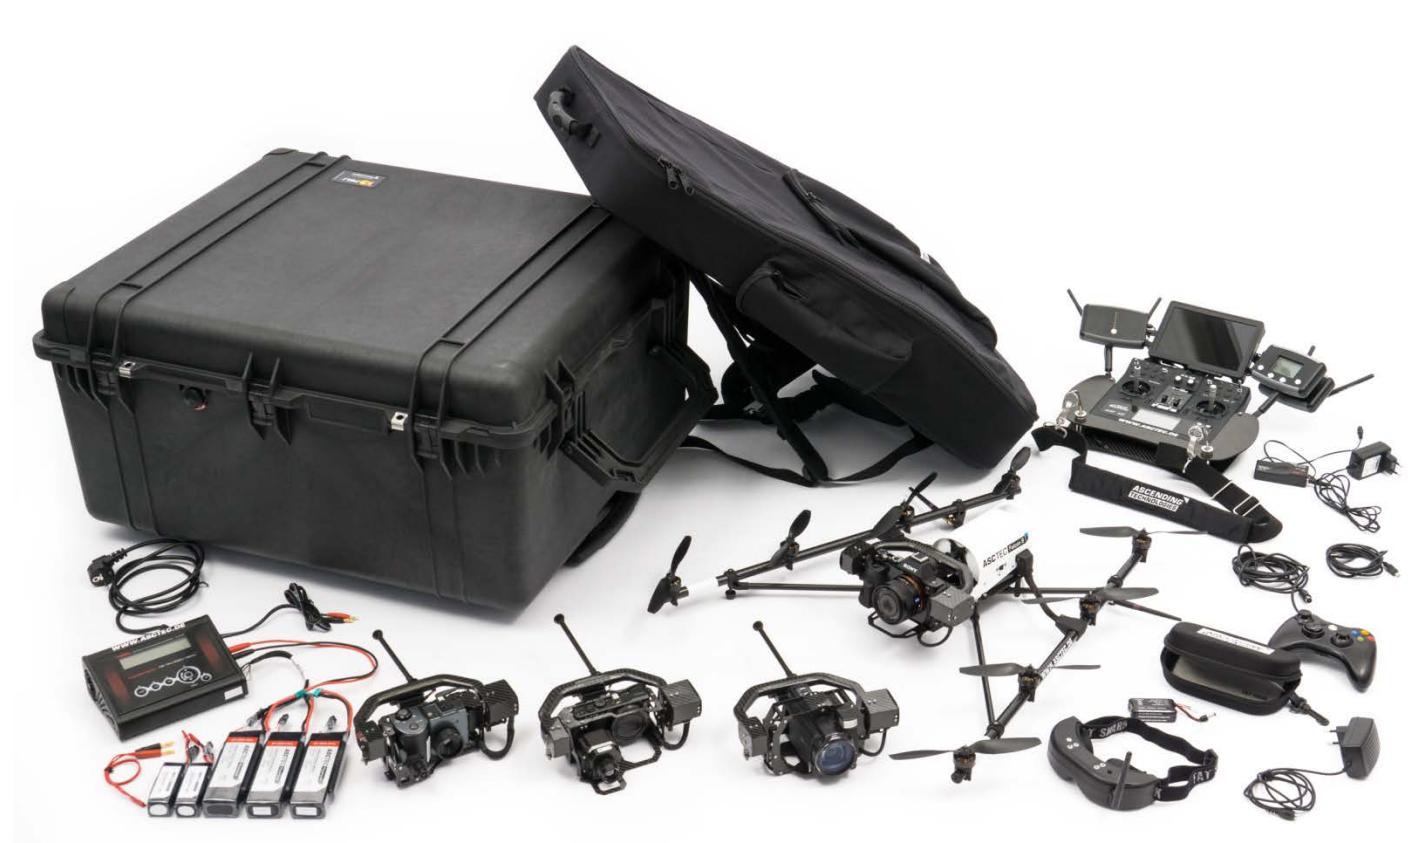
Figure 1: Used flight system AscTec Falcon 8 with equipment for the research project

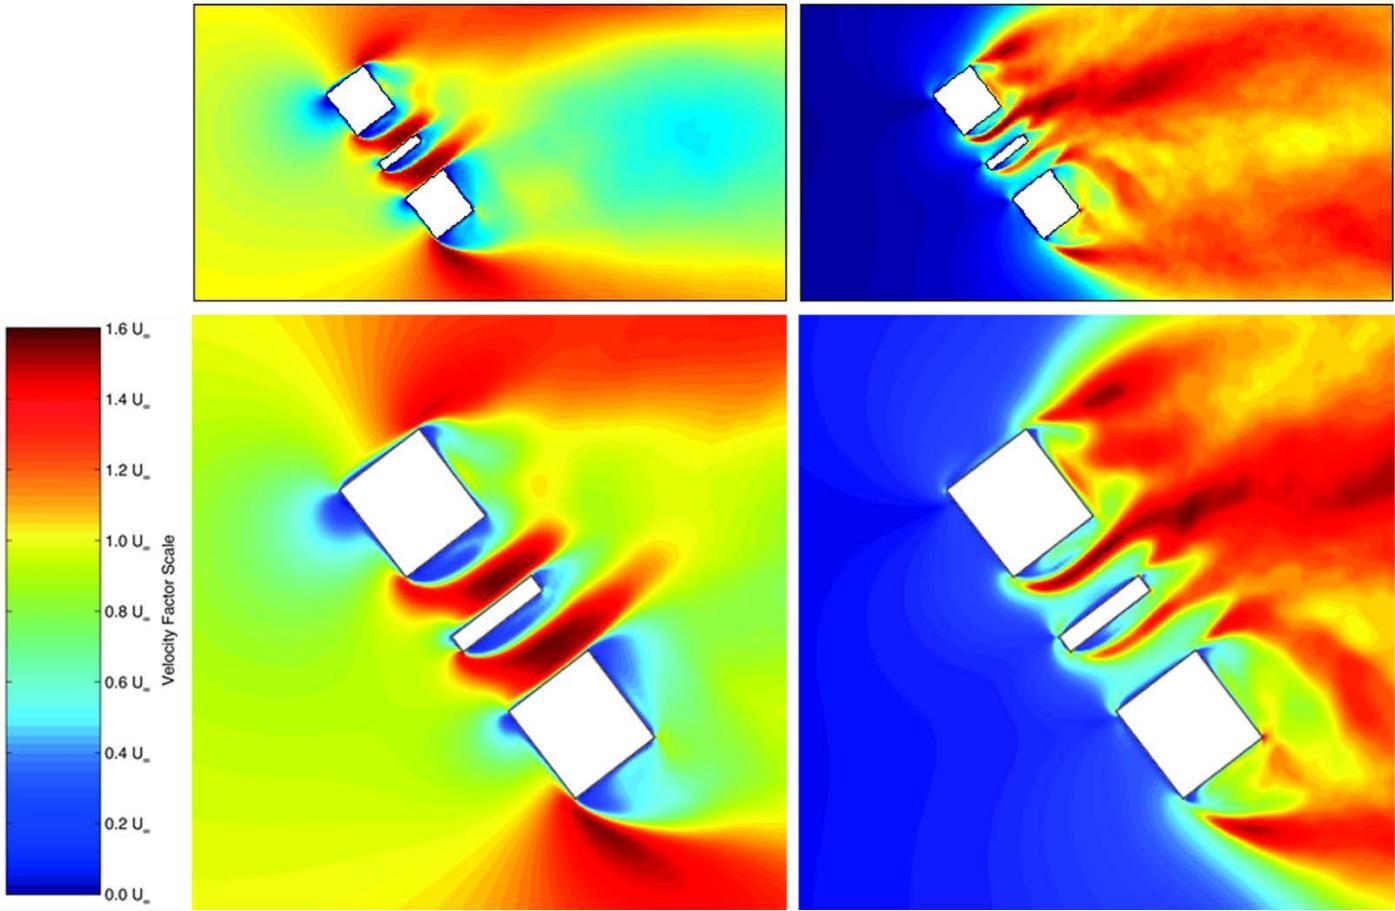
Figure 2: Numerical simulation of the mean wind field velocities (left) and the turbulences (right) of the reference object Cathedral of Magdeburg with a flow velocity of 10m/s and a flow angle of 52.5°

The second part of the project focussed on the investigation of the local aerodynamic wind field around the investigated structures. By performing numerical flow simulations using Computational Fluid Dynamics (CFD) methods, the critical areas like shadowed parts behind the structure or areas with extensive fluctuations in the wind velocities were particularly investigated. The description of the flow field was realised by visualisation of the mean flow velocity and its fluctuating components (turbulences). The results of this aerodynamic study of the wind conditions and the related structural parameters were used for a strategy of a methodical optimisation of the UAV-Technology and for the optimisation of the control and feedback control systems.

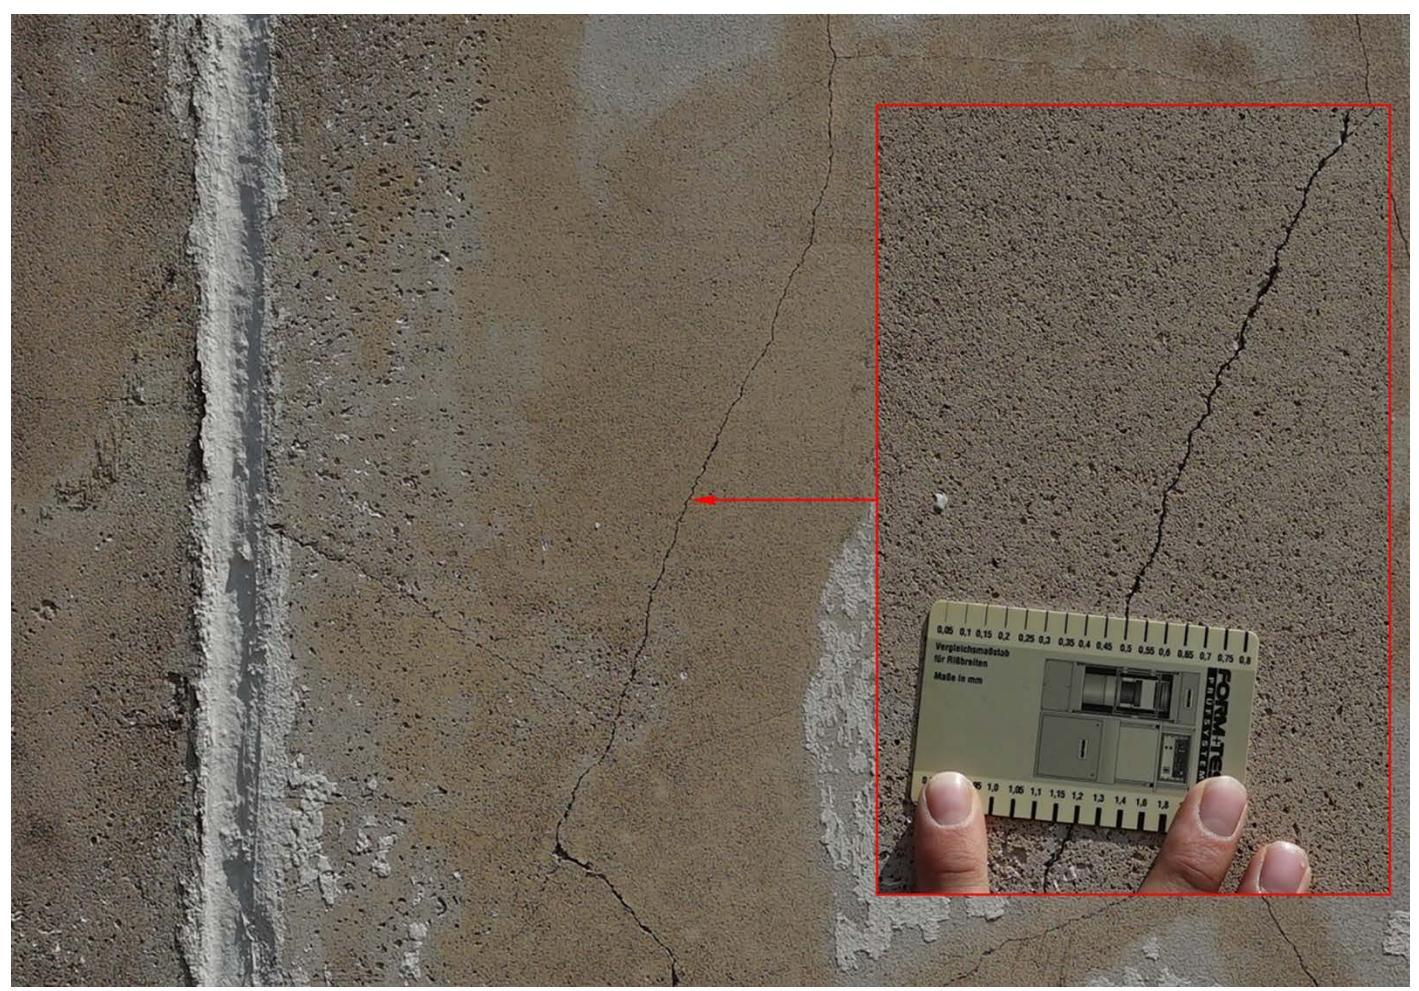
Figure 3: Detail of an aerial image of a crack on an concrete surface (recording distance: 7.5m, crack width: 0.5mm)

The essential criterion for the assessment was the users visual assessment of damages like cracks with a defined crack width. Further methods for data processing and utilisation were investigated intensively. Thereby the focus was on the applications of photogrammetric analysis of the aerial images for the generation of highly accurate 3D reconstructions of structures which could be used for automatic geometrical damage detection by performing cloud comparisons.

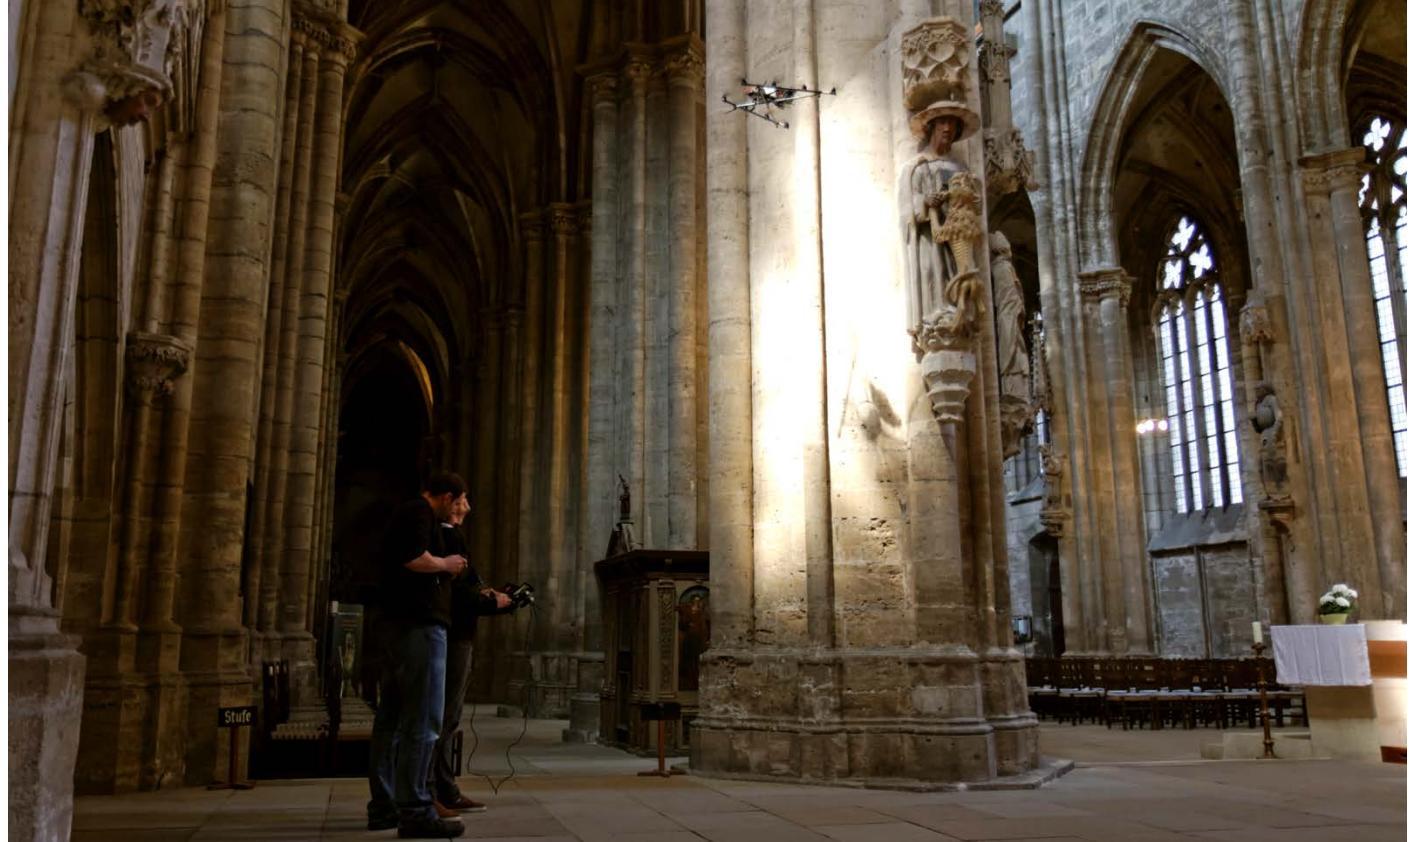
Figure 4: Manuel data acquisition of the sculpture of St. Hieronymus in the Cathedral of Halberstadt (Indoor team operation)

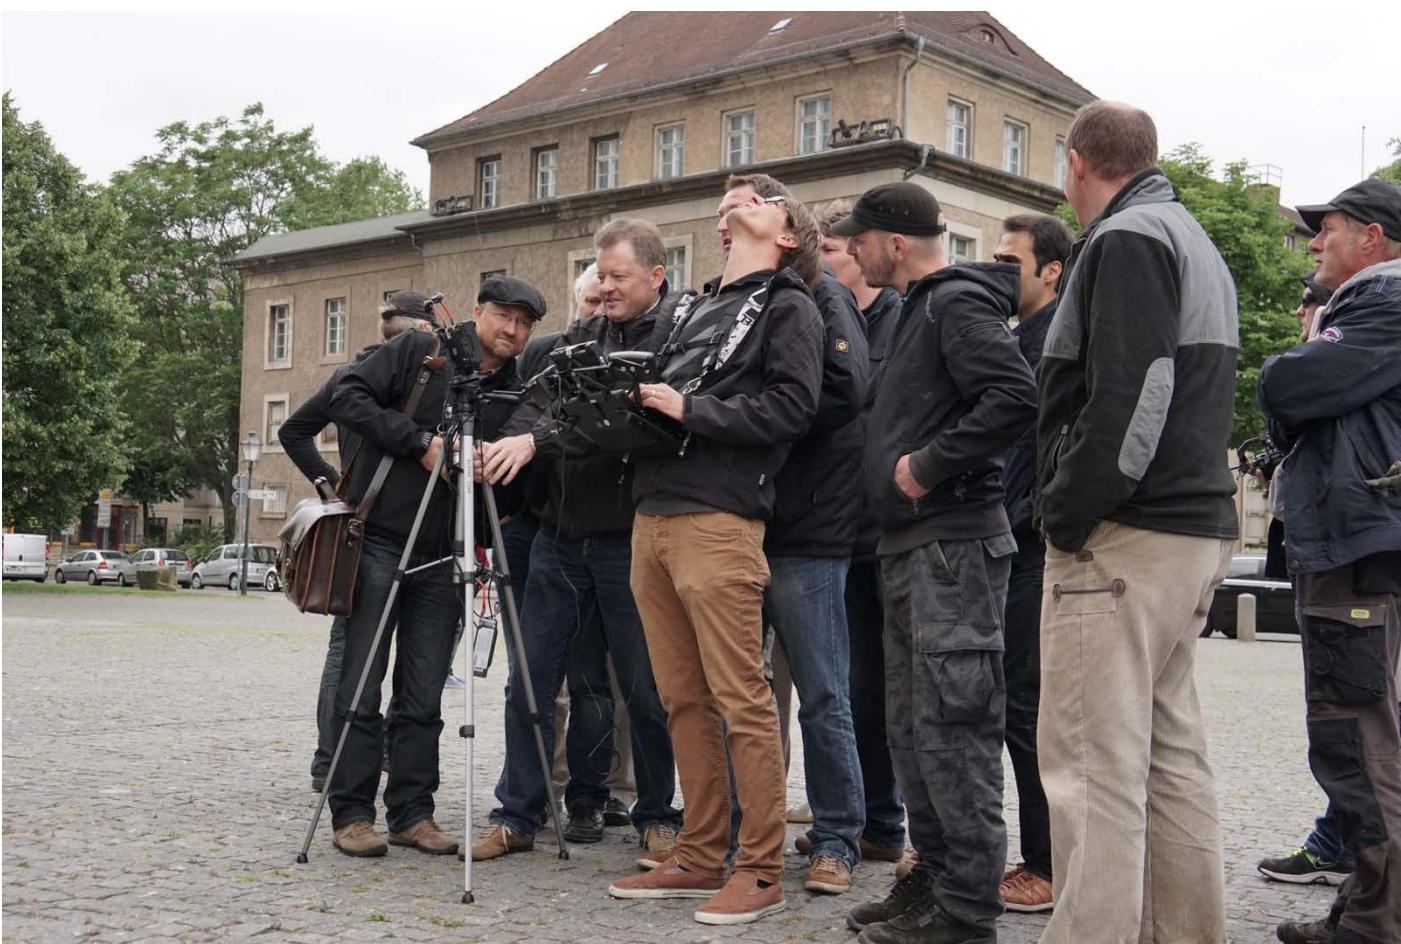
Figure 5: Outdoor team operation at the Cathedral of Magdeburg, Live-evaluation of the condition of the towers by experts

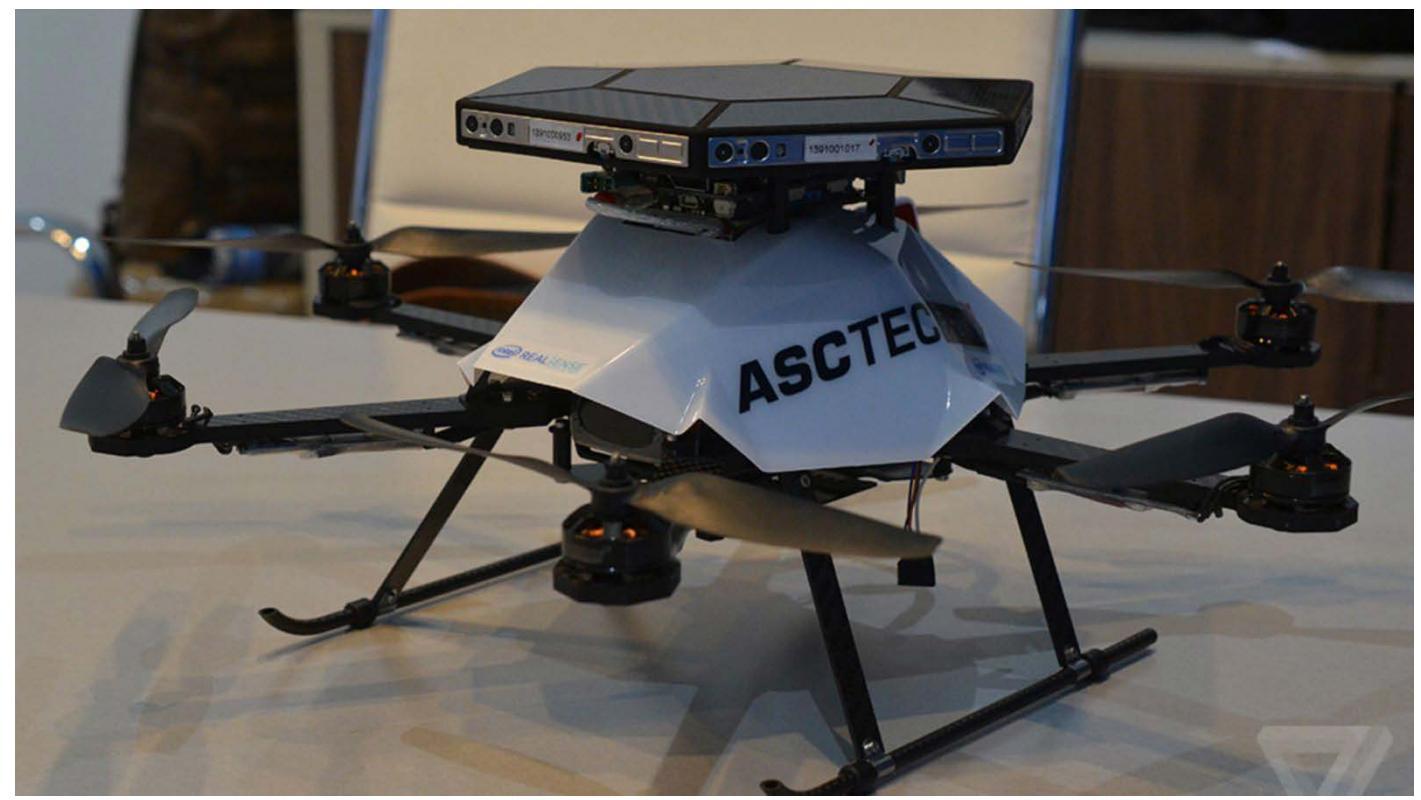
Figure 6: Used prototype AscTec Firefly with Intel RealSense-Technology for obstacle detection and avoidance

The essential element of the third part of the research project was the development of control and feedback control systems for collision avoidance. For this, the use of proximity sensors was investigated. The experimental implementation and tests were performed by the project partner Ascending Technologies. During the data capture of the reference objects, the application limits were identified. The second element was the investigation and the test of mechanical collision avoidance systems.

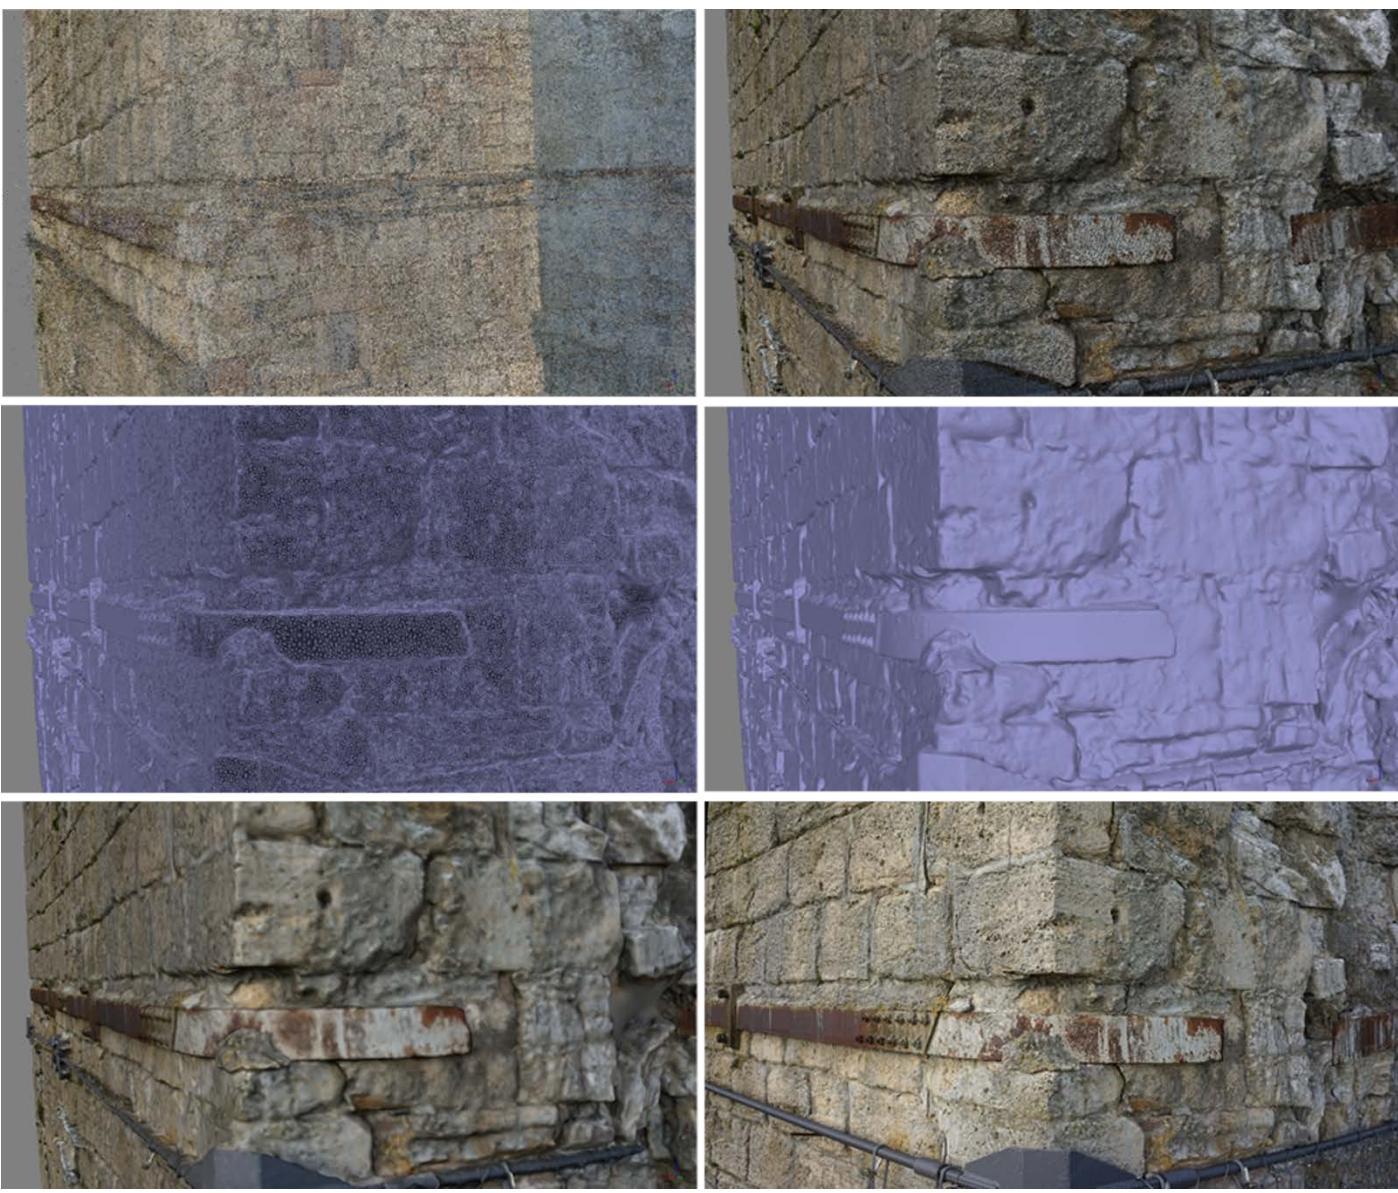
Figure 7: 3D reconstruction of a damage corner of the Leaning Tower of Bad Frankenhausen
