Service Life (Model) for Bituminous Roofing

Erik Brandt¹
Tommy Bunch-Nielsen²

T 22

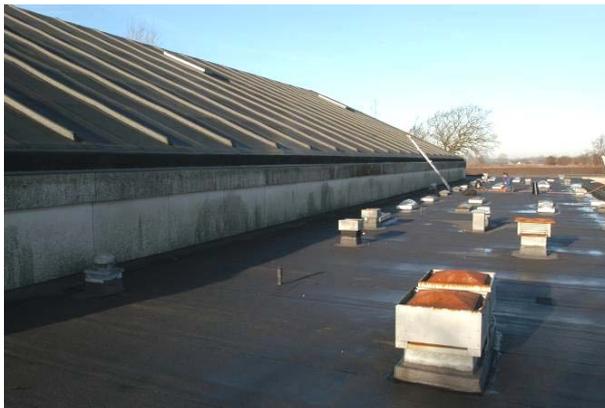
Figure 1. Example on two roofs with different slope but same roofing felt. Both were assessed during the survey.

The slope of the roof is of importance for the time of wetness and for the risk of water ponds. Ponds on the roof may lead to a risk of a build-up of ice which can remove the protective granules or even tear the roofing material apart due to temperature movements under freeze-thaw cycles. The influence of the slope is expressed according to the following:

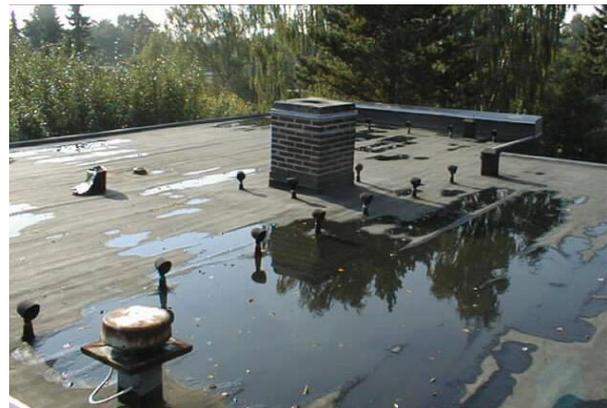
Figure 2. Example of a dead low-sloped roof with ponding water. Ponding water leads to a risk of reduced service life due to increased exposure of the roof membrane to moisture and freeze-thaw cycles.

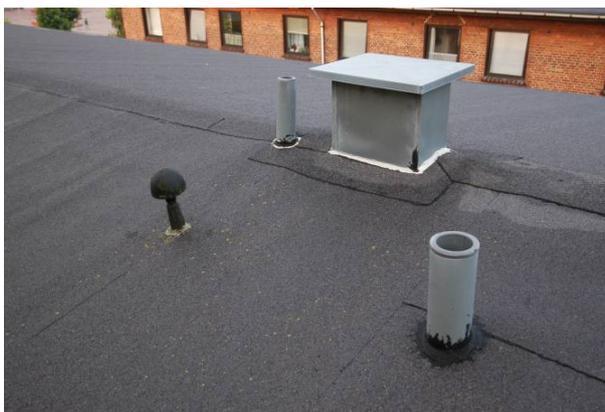
Figure 3. Example on different penetrating details normally seen on a roof.

The experience from the few problems in the warranty shows that it is often the details of the roof that fail – which is in accordance with the findings in the survey.

Therefore the service life time model should emphasize the use of correct details in the roof design more in order to secure against water infiltration etc. It is proposed that the model is improved by using a more detailed factor for design as shown below.

¹⁾ Critical details are details not in accordance with the design rules as stated in the Danish design guide for roofs or wrongly executed details, e.g., too close together to ensure watertightness. An example of a critical detail is a flashing with a height lower than the minimum height 150 mm as stated in the Danish design guide. In the table 1 m flashing is considered equivalent to 1 penetration.

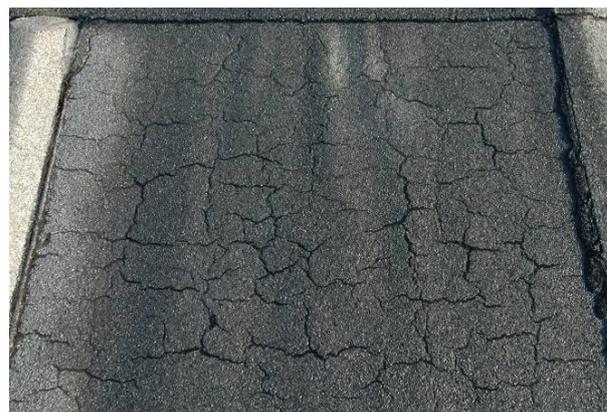
Figure 4. Superficial "cracking" in the bitumen on steep surfaces leads to reduced protection by the granules.

<i>Overall impression:</i>	Some deformations in the substrate (roof elements) are clearly visible. The roof covering itself looks acceptable.
<i>Granule covering:</i>	Generally good. "Surface cracks" on the west side of the building
<i>Tightness of welding seams:</i>	Ok
<i>Fastening:</i>	Ok
<i>Cracks in the roofing felt:</i>	Starting to appear on angle fillets
<i>Blisters:</i>	None
<i>Folds in the covering:</i>	None
<i>Cracks at flashings etc.:</i>	None
<i>Damage around roof lights:</i>	No rooflights
<i>Algae etc.:</i>	Some algae on north facing surfaces of angle fillets
<i>Valleys:</i>	No valleys
<i>Drain:</i>	The roof is drained over the edge of the roof
<i>Further remarks:</i>	None

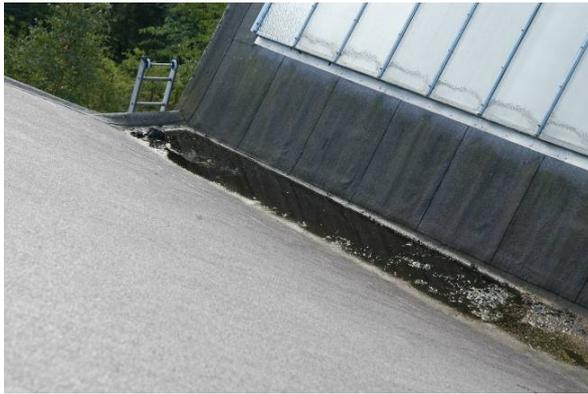
Figure 5. Example of ponding water in a valley. In this case the water remained in the valley almost permanently and, as a consequence, the protective granules were gone.

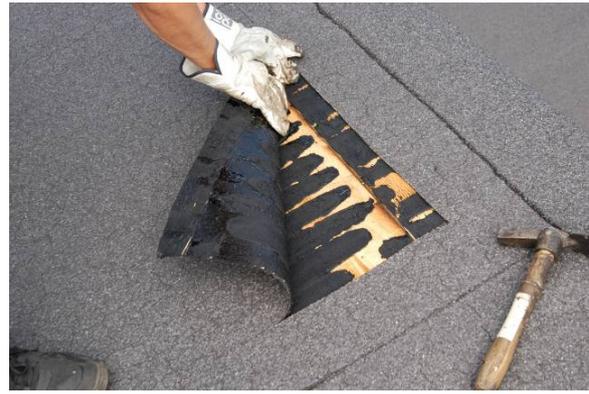
Figure 6. Sampling of specimen for laboratory testing.

Besides specimens of the membrane were taken out from the surveyed roofs and the membranes were tested on the labs of the producers to detect any changes in properties during the use.

Laboratory tests on samples taken from the inspected roofs were performed by the 2 Danish producers in their own laboratories. The properties tested were those considered most crucial for a long service life. The roof membrane must remain watertight, weather-resistant and be able to resist influence from the underlying substrate.
