# THE CONDITIONS AND CONSTRAINTS FOR USING REUSED MATERIALS IN BUILDING PROJECTS

Authors: Mats Eklund (Linköping University, Linköping, Sweden); Svante Dahlgren (TP Property Consultant, Norrköping, Sweden); Agnetha Dagersten (Stångåstaden Housing Company, Linköping, Sweden); Gunnar Sundbaum (Sundbaums AB, Linköping, Sweden)

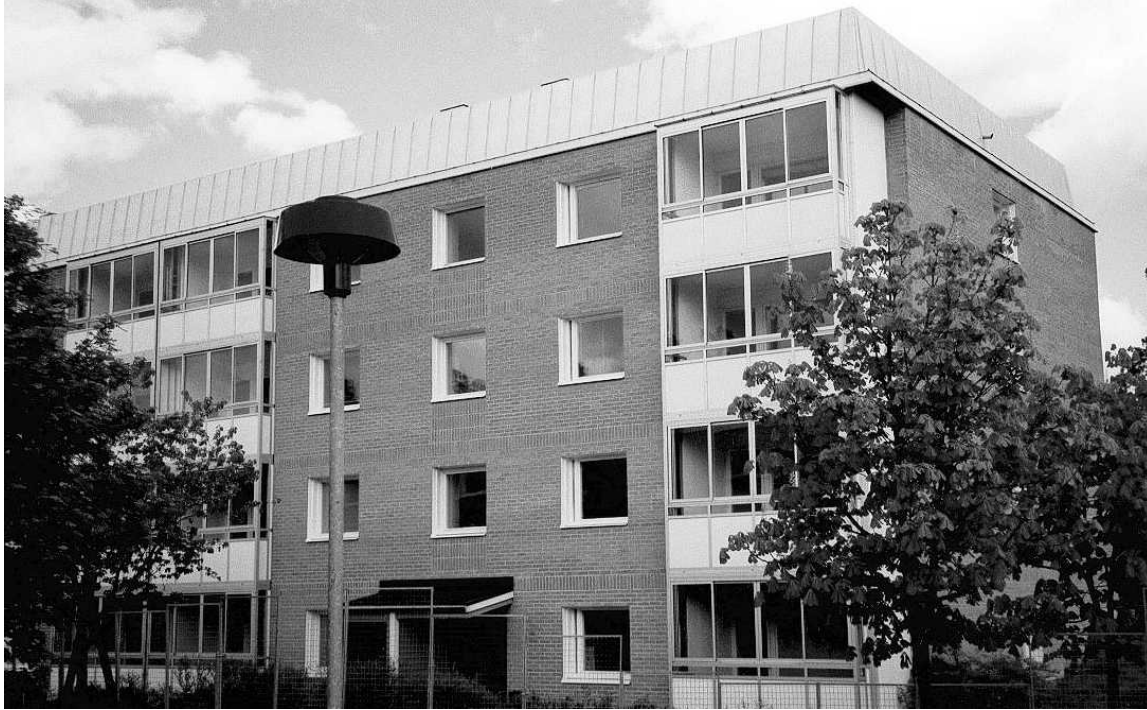
***Figure 1.** This is one of the apartment buildings in Finspång, Sweden that was torn down and functioned as a material source for a new building in Linköping, Sweden.*

The Udden project was started in 1996, when Gunnar Sundbaum was exploring ways to deal with empty buildings in Finspång, Sweden. This town has a long industrial tradition, but improved productivity in industry has decreased the need for labor. In Finspång, multi-family units are owned mainly by a municipally-controlled company that faced a difficult financial challenge for the first time. In 1996, 325 of the 2400 apartments were empty, costing the company a great deal of money. The company's earlier strategy to meet such problems was to improve the housing; but this was no longer sufficient since the causes of the problem of empty apartments was related to the economy and the location of the apartments (cf. 6). It became obvious that the buildings had to be demolished to decrease the number of apartments and to simultaneously try to improve the quality of living in those areas by creating more space between the remaining buildings. It was decided that five buildings containing more than 100 apartments would be demolished. They were built in the 1960s, but they were renovated several times since then and were in good condition.

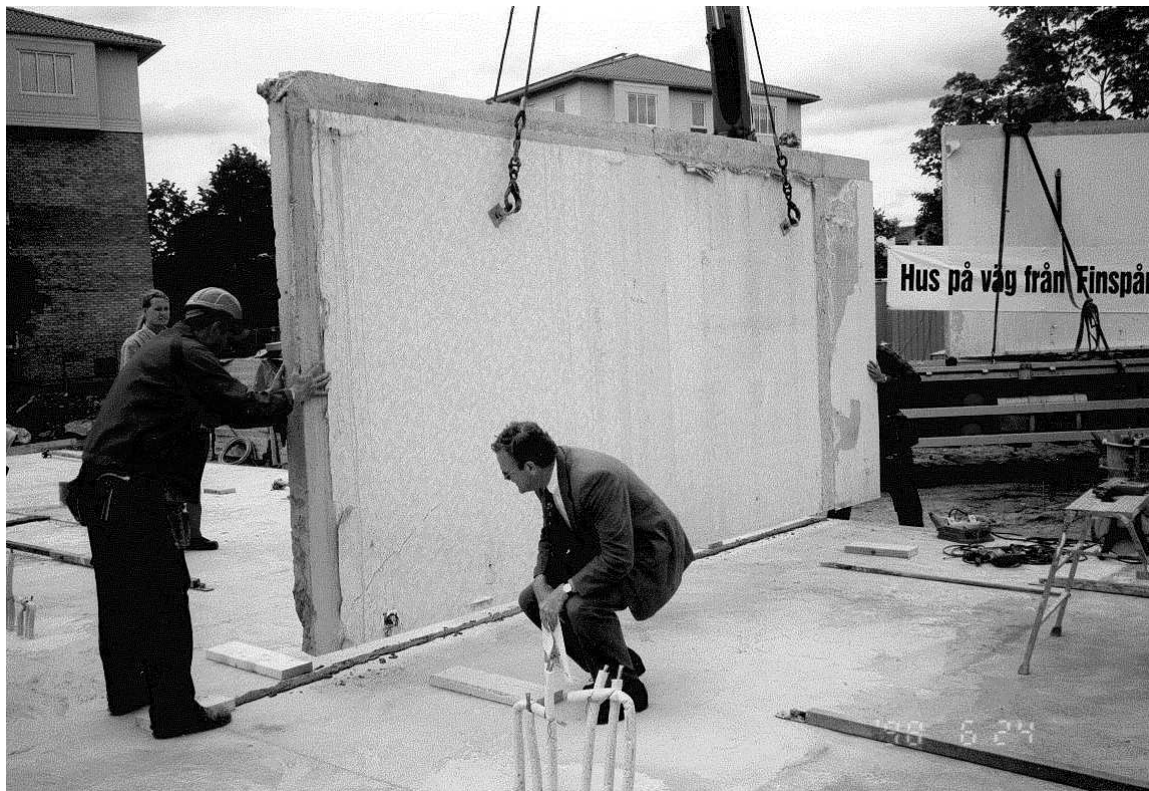
**Figure 2.** Concrete elements cut from cast in-place concrete walls delivered to the building site in Linköping under the supervision of the county governor, Björn Eriksson.

In order to make use of as much of the materials and products as possible, the general contractor carefully deconstructed two of the buildings in Finspång. The buildings were constructed mainly out of concrete and beams cast in-place. To reuse these materials, they were cut with a diamond saw. The deconstruction was predicated on what the new building could use. Materials and products from about 50 larger apartments in the two buildings that were deconstructed were used to construct a building containing 22 smaller apartments (totaling 1070 m<sup>2</sup>). In the Udden project, reuse was not restricted to concrete walls and beams (Table 1), although this is the most conspicuous feature of this building (Figure 2).

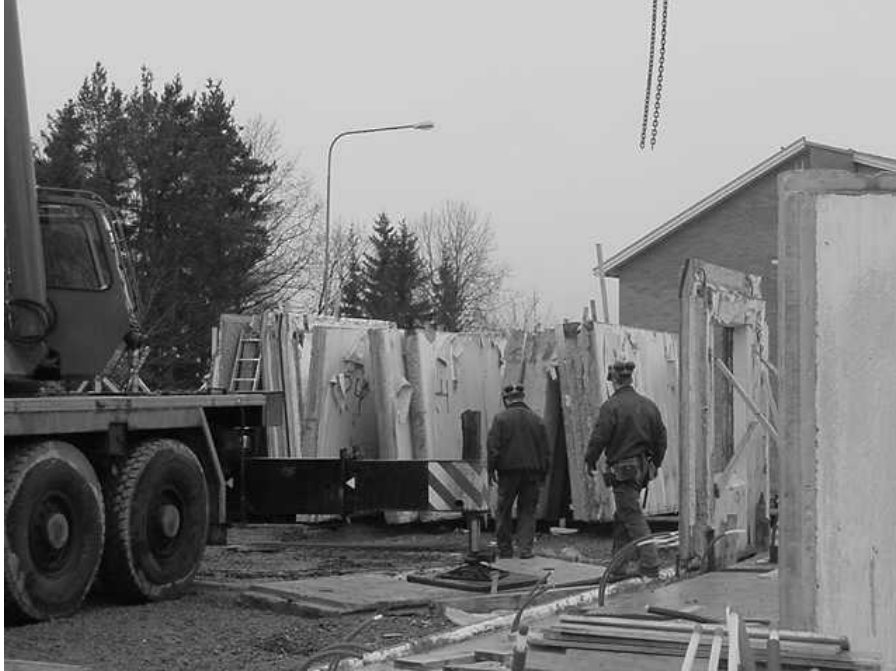
**Figure 3.** The concrete elements from the refurbishment project arrived at the building site in Linköping, Sweden.

Reuse in the Nya Udden project focused on the concrete elements more than the Udden project did (Table 2) (Figures 3 and 4).

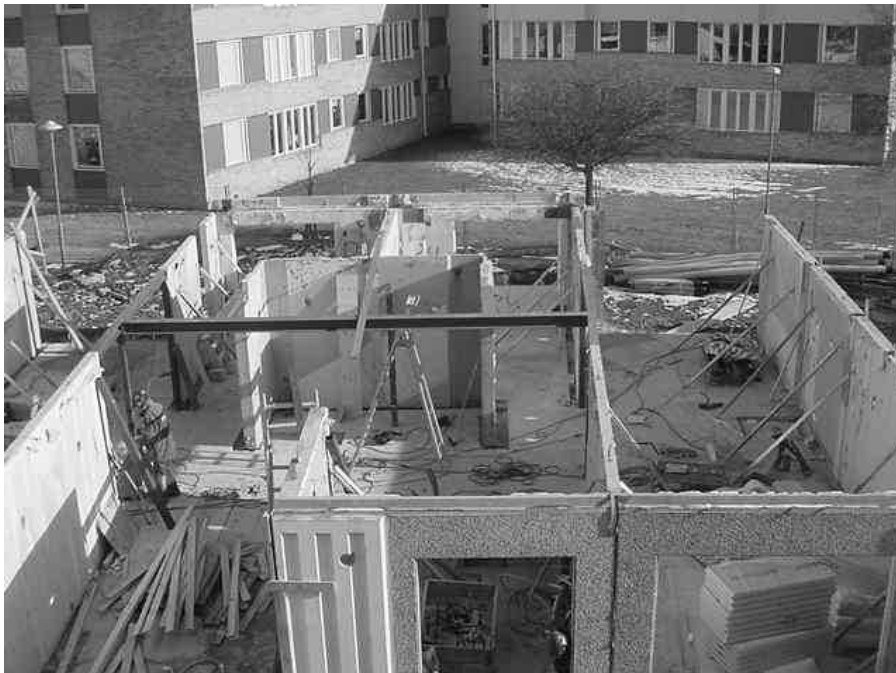
**Figure 4.** Frame construction in Nya Udden. Additional steel supports were used to further reinforce the building.

To make sure that the construction at Nya Udden would suffice in terms of pressure failure, some tests were performed on the beams. It was no problem to satisfy standards in this respect, but to ensure safety over-dimensioning of supports was also applied.
